CCW IMPOUNDMENTS INSPECTION REPORT

GORGAS STEAM PLANT WALKER COUNTY, ALABAMA

**PROJECT NO. 09-4157
SEPTEMBER 2009**

**CCW IMPOUNDMENT ASSESSMENT REPORT
WILLIAM CRAWFORD GORGAS ELECTRIC
GENERATING PLANT
WALKER COUNTY, ALABAMA
PROJECT NO. 09-4157**

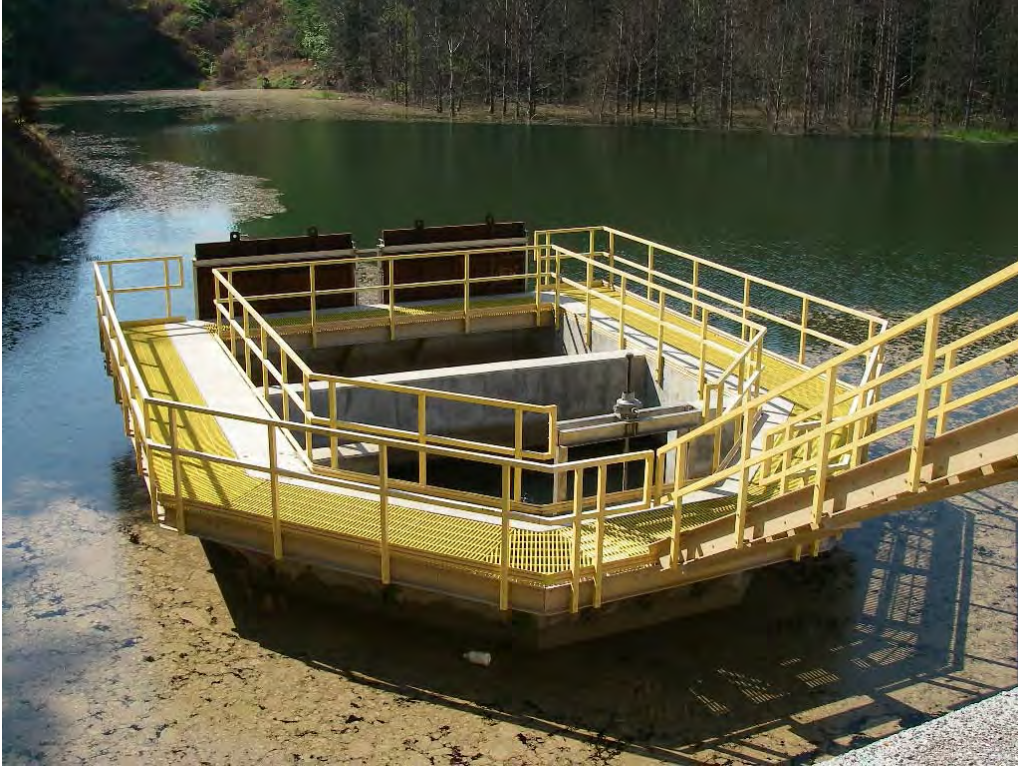
PHOTO 1: RATTLESNAKE DAM WEIR FLOW INTAKE STRUCTURE

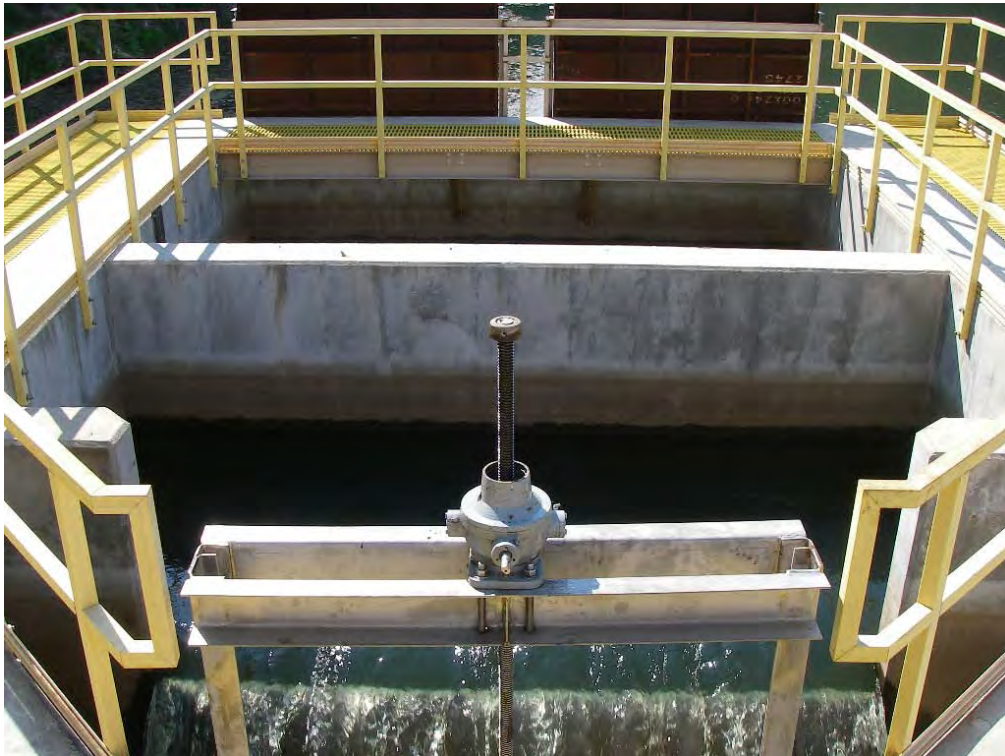
The weir intake structure is a new reinforced concrete structure in excellent condition. This structure outlets into a 48-inch diameter corrugated metal pipe that carries decant water down the hill to the NPDES permitted release point. The release point is under water; therefore observation of the water at the point of discharge was not visible. Water at the point of entry was clear water. (*See Photo 2*).

PHOTO 2: CLOSEUP OF WEIR INTAKE

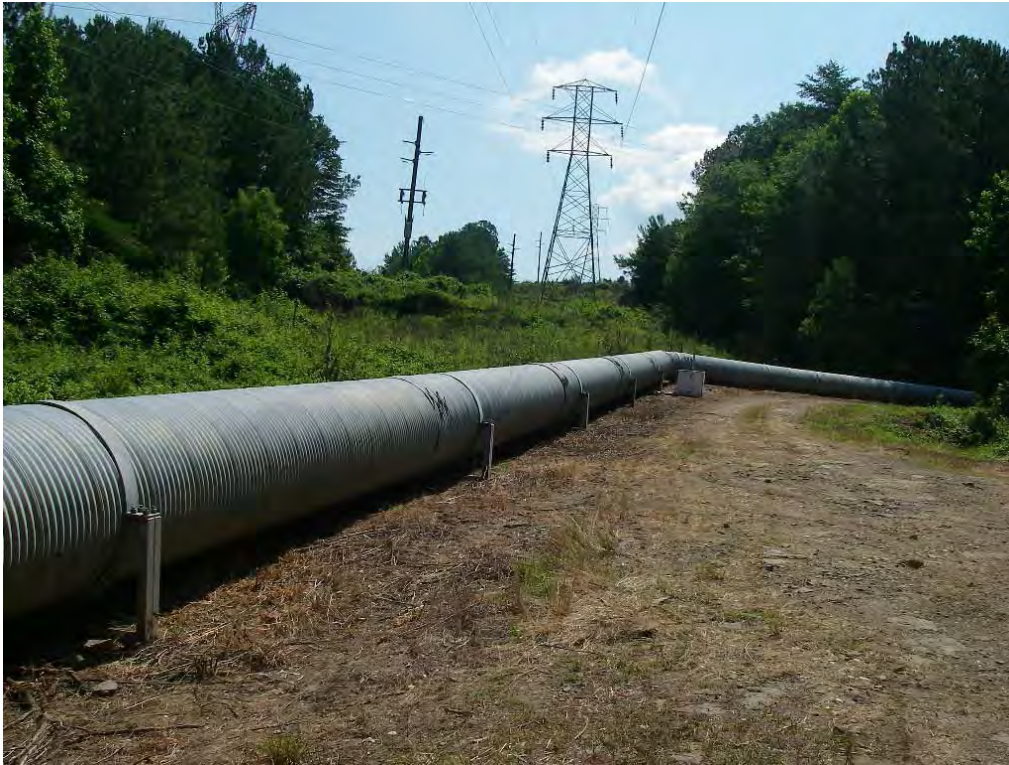
**PHOTO 27: DISCHARGE LINE FROM RATTLESNAKE DAM TO BLACK
WARRIOR RIVER**

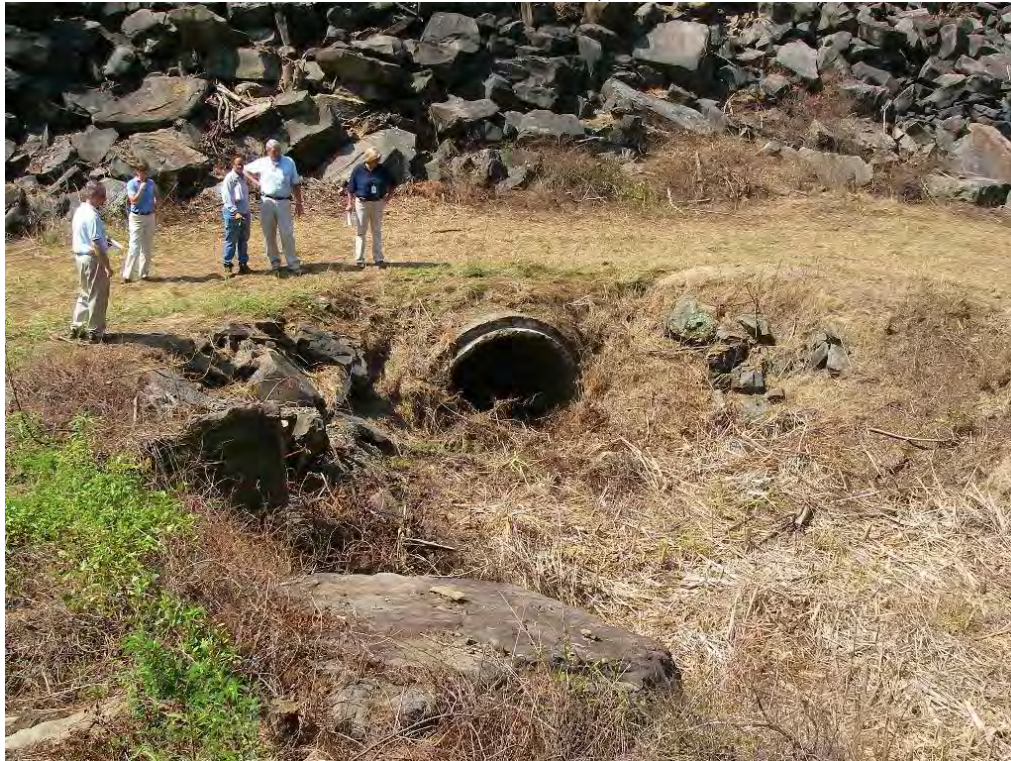
**PHOTO 15: ORIGINAL BYPASS CHANNEL & CULVERT (ABANDONED,
LOOKING S)**

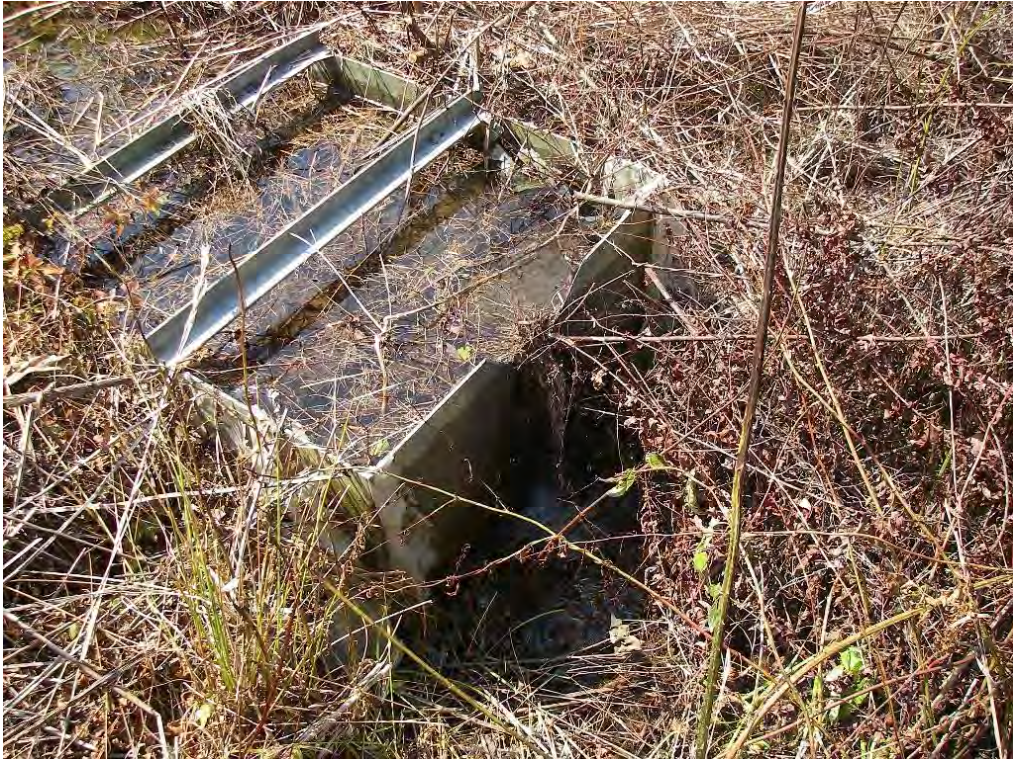
PHOTO 18: OVERGROWN SEEPAGE MEASUREMENT WEIR

In conjunction with Recommendation No. 1, the existing weir box at the toe of the downstream slope of Rattlesnake Dam should be cleaned out and repositioned, or replaced with a larger weir if necessary, to collect the seepage flow along the downstream toe observed at the time of inspection. As much of the seepage currently visible should be collected as possible and the small ditch creating the current flow path should be kept as clear as possible to facilitate observations of changes in volume, turbidity, or location of new seeps. Such information, along with the flow measured at the box should be recorded as a part of Recommendation No. 1, so that seepage trends can be established and reviewed easily. In the event of increased seepage flows, the installation of additional instrumentation and a more involved monitoring program may be warranted.

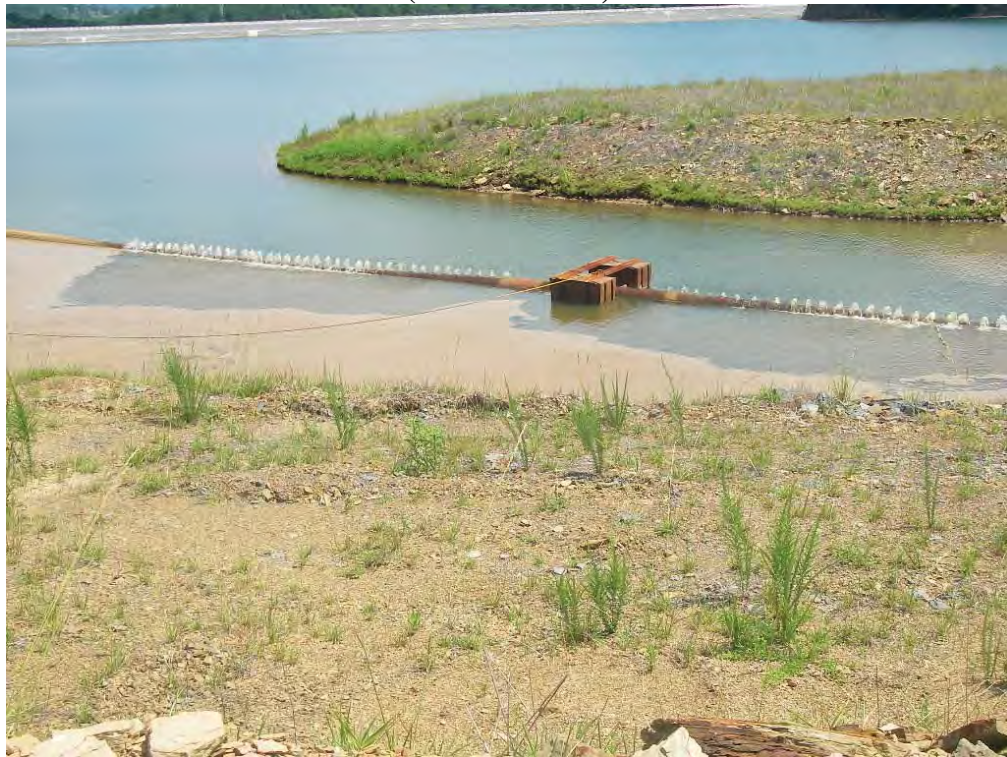
**PHOTO 32: BUBBLER AERATION LINE AT INTERMEDIATE DIKE
(LOOKING E)**

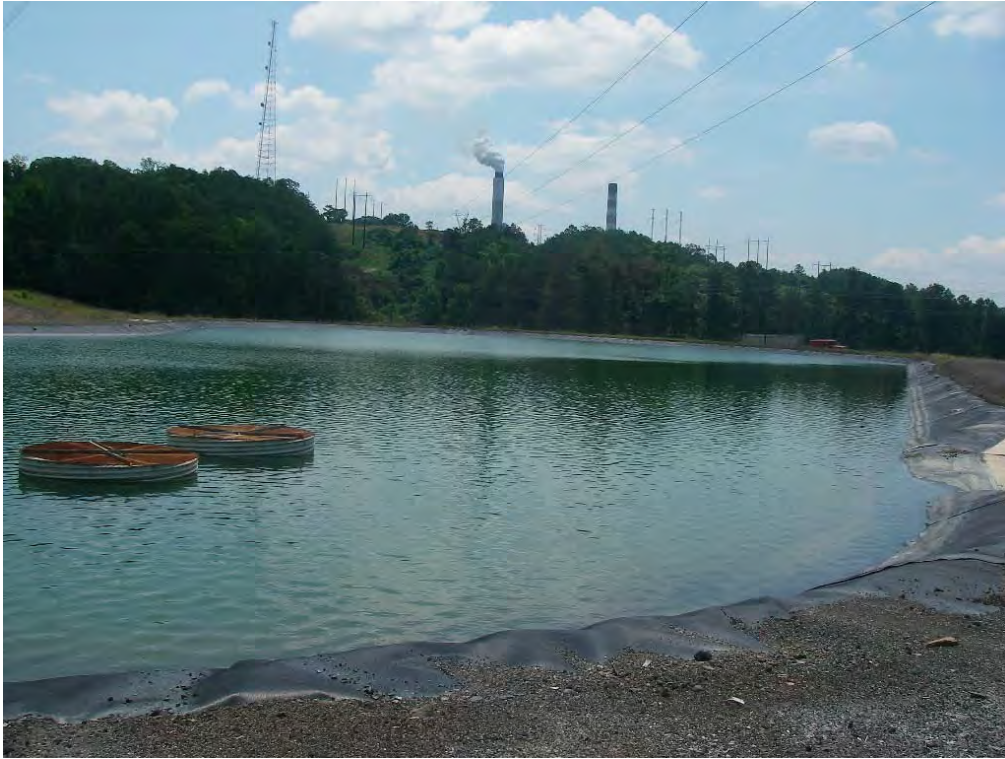
PHOTO 35: DECANT PIPES IN SEDIMENT BASIN

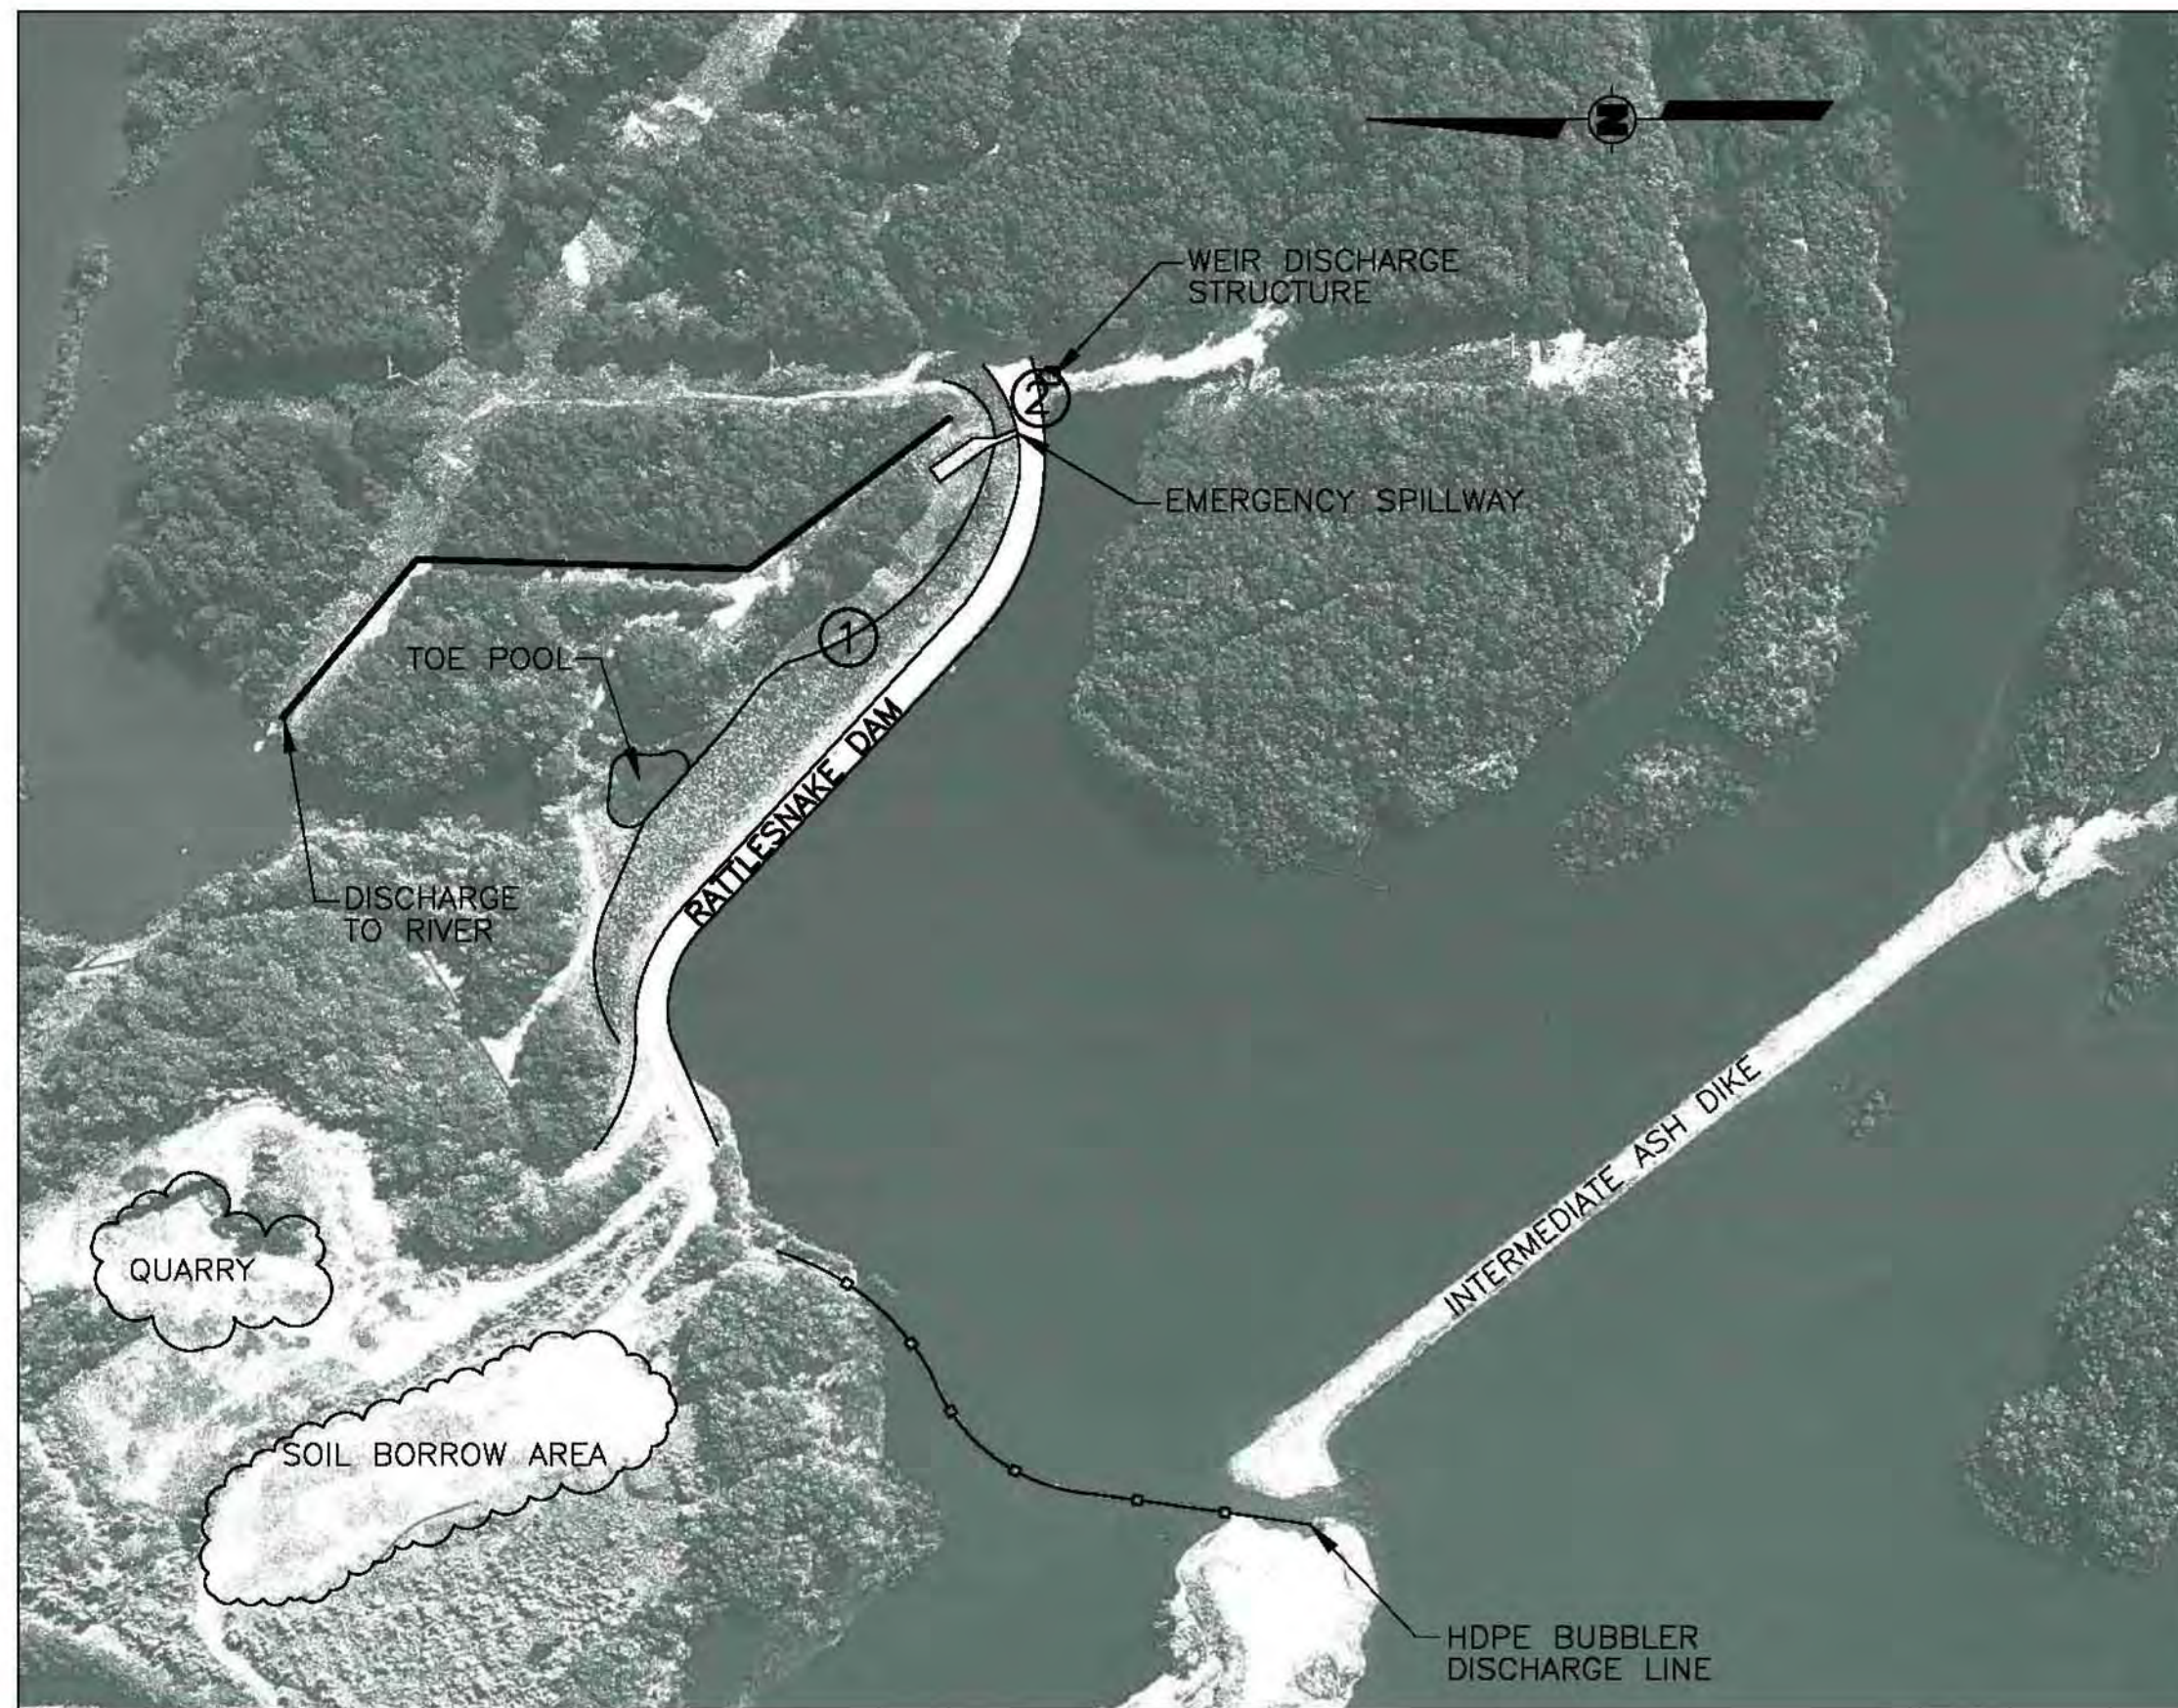
FIGURE 3
RATTLESNAKE DAM
AND FEATURES
GORGAS PLANT
DAM SAFETY INSPECTION
PREPARED FOR
USEPA
WASHINGTON, D.C.

- LEGEND**
- ① APPROXIMATE LOCATION OF SEEPAGE FROM TOE.
 - ② CRACKING IN RCC FACING BLOCK NOTED HERE.
